# Manhole Inspection Summary

Manhole # S27E\_\_048MH

Insp Date: 1/15/09 1:34 PM

**Location** Address: **Vine St.**

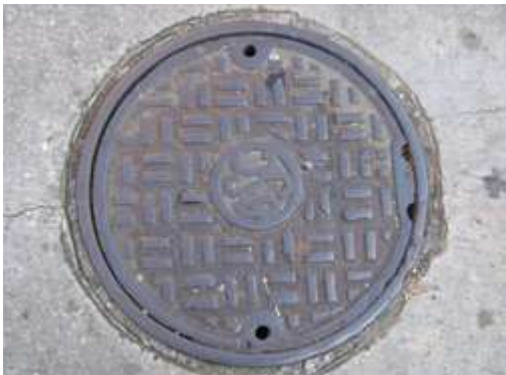
Misc

cover

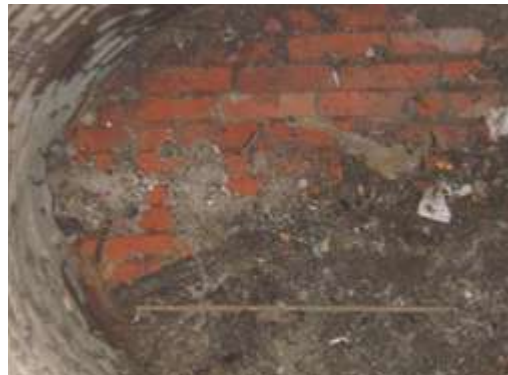
Defect 3

Condition: ☐ Sound ☐ Cracked ☐ Root Intrusion ☐ Deteriorated ☐ Leaks ☒ **Debris**

channel debris

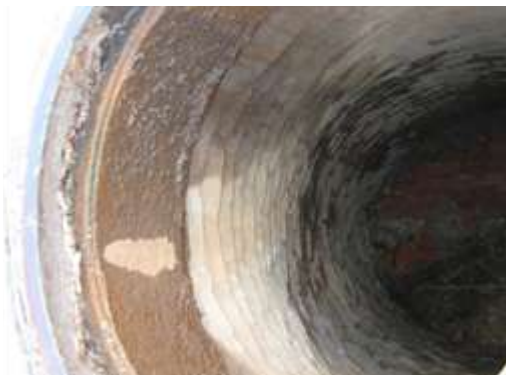
Defect 4

Condition: ☐ Sound ☐ Cracked ☒ **Leaks**

frame infiltration at cover

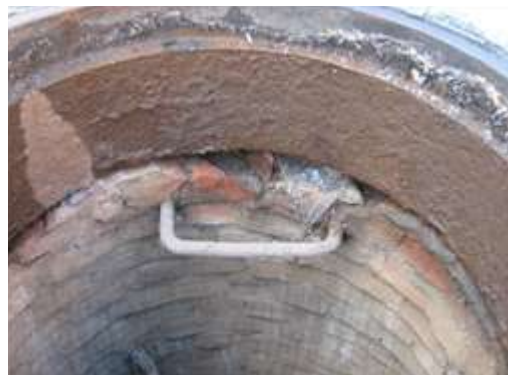
Defect 6

Condition: ☐ Sound ☐ Cracked ☐ Root Intrusion ☒ **Loose Brick** ☒ **Deteriorated**

Infiltration: ☐ None ☒ **Joint** ☐ Cracks ☒ **Mortar** ☐ Roots ☐ Wall

chimney loose bricks and deteriorated, infiltration at mortar

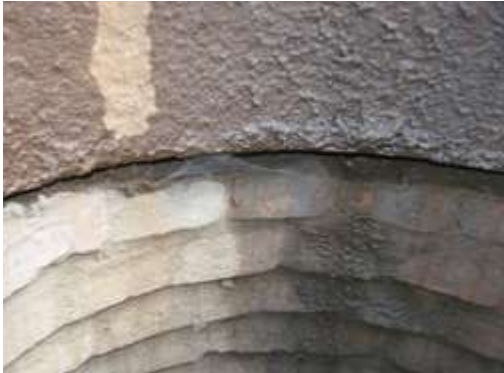
Defect 5

chimney infiltration at frame joint

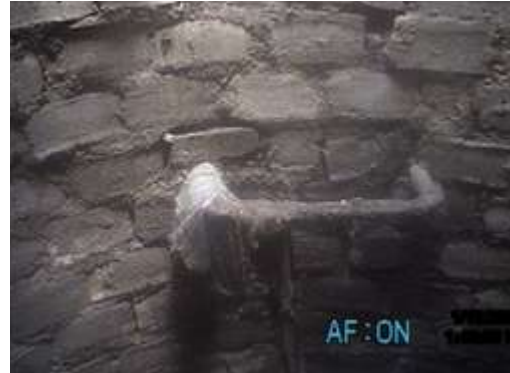
Defect 2

Count: **5** Missing: **0** ☒ **Corroded**

☒ **Evidence Of Surcharge** Depth: **1** (ft.) ☐ Active Surcharge Present

surcharge evidence 1 foot, steps corroded

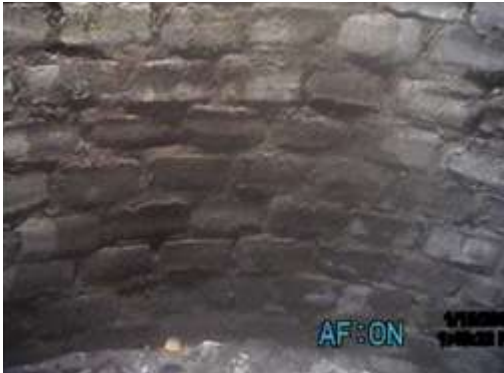
Defect 1

Infiltration: ☐ None ☐ Joint ☐ Cracks ☐ Mortar ☐ Roots ☒ **Wall**

barrel infiltration at wall

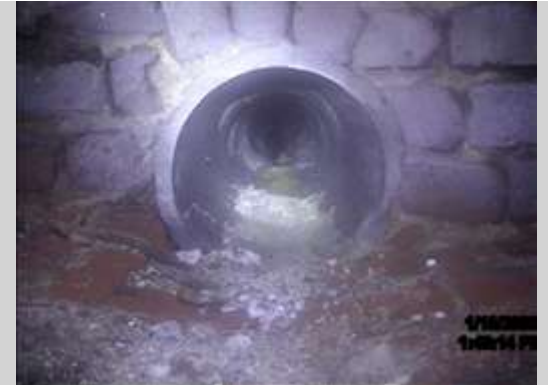
12 O'Clock Outflow

8 in. Circular Gravity Sewer  
Pipe Out @ 12 O'Clock

Infiltration: **None** Pipe Seal Cond: **Sound**
